Corrosion and its effect on wire rope used in underground coal mines

R. P. Singh, Mousumi Mallick, M. K. Verma

Failure analysis of a guide rope used in coal mines:

Failure analysis of a winding rope used in coal mines:

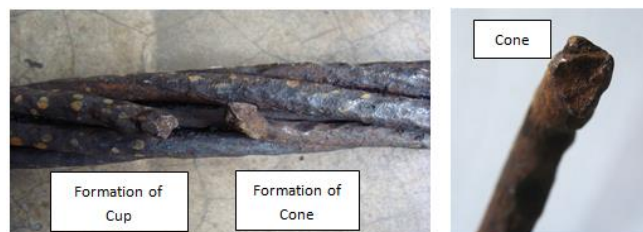
Visual examination revealed that the top end and bottom end portions of the failed guide rope was physically in good condition while in the broken failed portion out of seven wires, one wire have been broken out (Figure 5 & 6). After cleaning, the broken portion of the guide rope was found to have heavy wear and pittings (Figure 7).

Figure 6: After cleaning of failure broken end

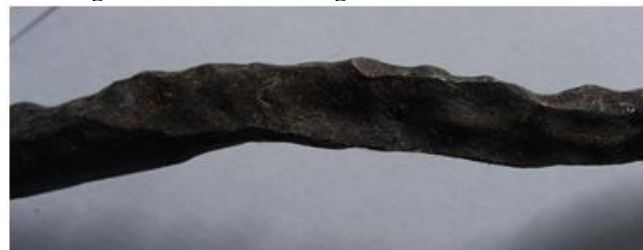
Figure-7: Wear, corrosion & pittings in one wire

The un-galvanized round steel guide rope wire sample on physical examination revealed abrasive wear, helical indentation marks, nicking and severe corrosion pittings on the surface of the wire.

Max. Percentage reduction in diameter: 57.44%

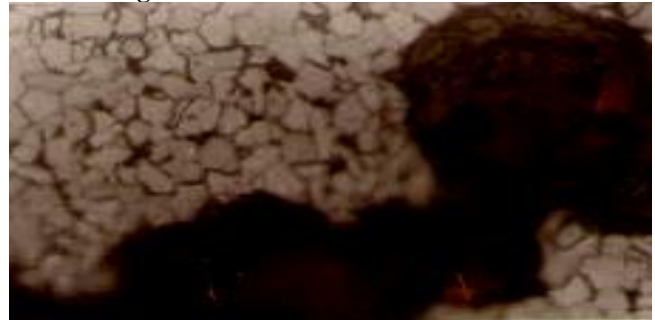
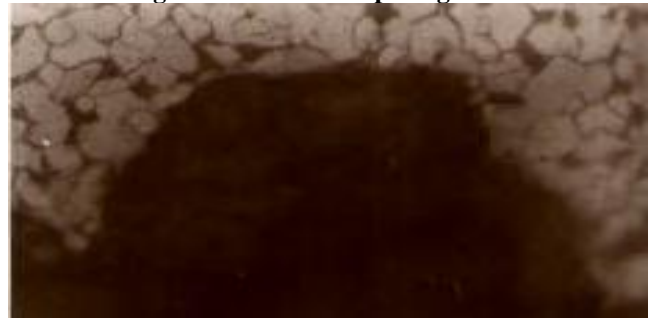
After etching in 2% nital solution the sample revealed normalized structure with uniform distribution of fine pearlite in ferrite matrix (Figure. 9a) and corrosion pittings along the grain (Figure 9b,9c,9d) of low carbon steel on the surface of the wire both in transverse section and longitudinal section.

Figure 9b: Corrosion pittings 400X

Figure 9c: Corrosion pittings 400X

Figure 9d: Corrosion pittings 400X

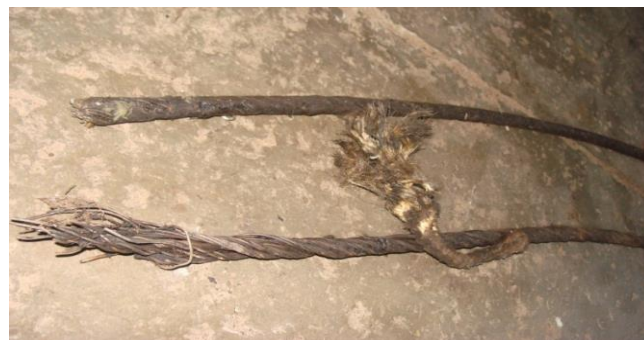
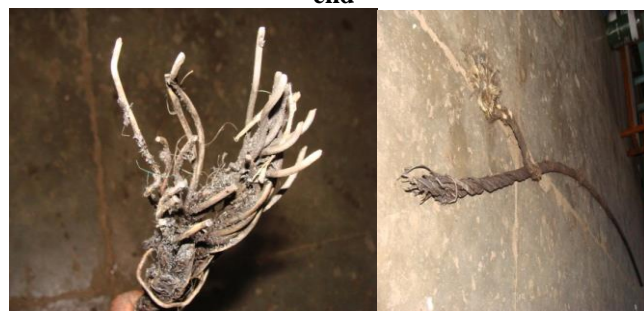
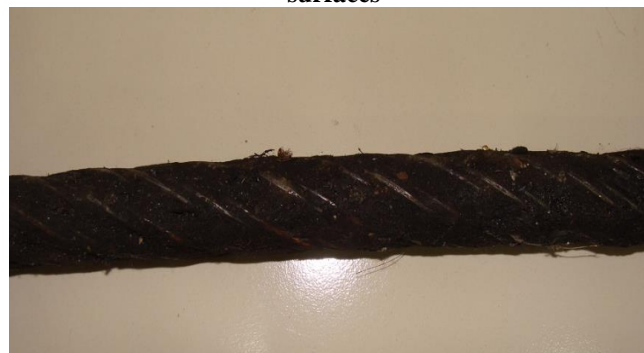
Figure 7: upper one – Fresh piece, Lower one - Broken end

Figure 8: Fracture Rope Samples showing broken surfaces

Figure 9: Fresh piece of rope

From the above figures it is clear that fibre core of the rope has come-out of the fracture end. The fracture end of the rope was badly damaged. The causes of the failure can be detailed out from the following Metallurgical examination.

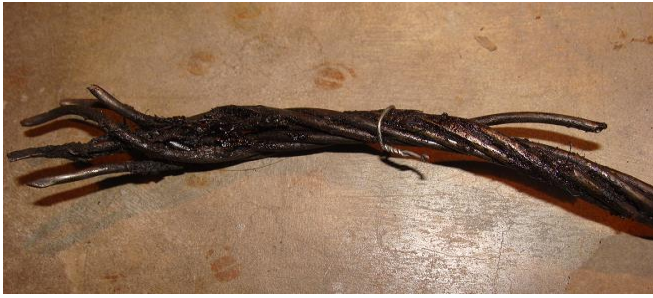
One wire of the strand has also been broken from the middle apart from the normal fracture of all the seven wires. The lay length was 172mm (Figure 10)

Figure 10: Broken wire of strand 1

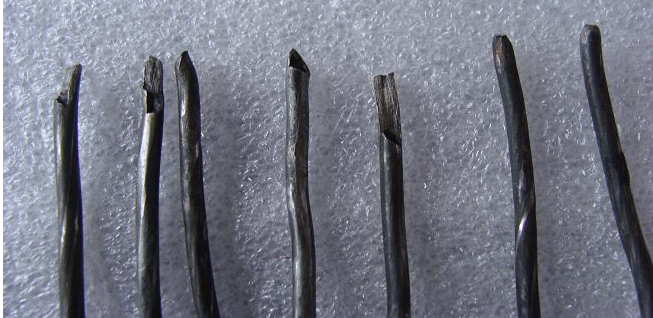
Types of fractures are: two wires of conical tensile failure and five wires of Corrosion fatigue failure (Figure 10a).

Figure 10a: Types of fracture of strand 1

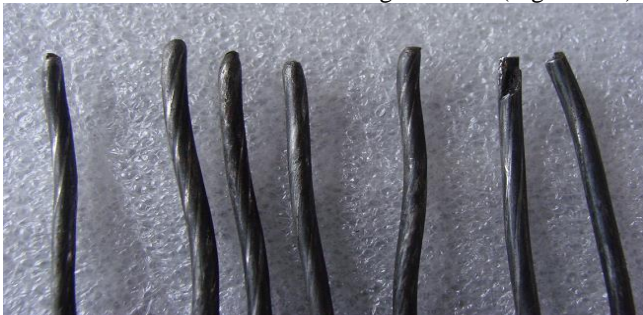
This strand was elongated and becomes straight having longest lay length among all of 220mm. The nature of fractures comprises of out of 7 wires, 5 wire of conical tensile failure and 2 wires of corrosion fatigue failure (Figure 10b).

Figure 10b: Types of fracture of strand 2

The above Figures indicate the Conical tensile and fatigue failure fracture of the rope and no. 2 Strand showed elongated i.e. lay length revealing the action of the heavy load on the particular strand.

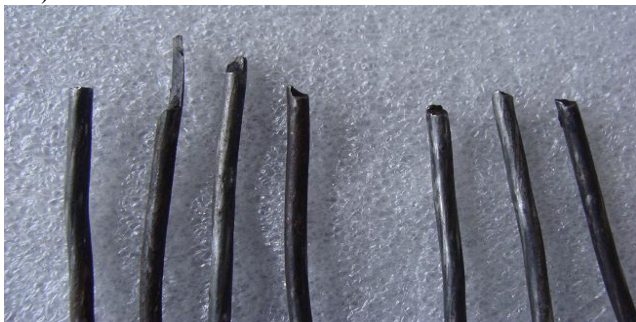
Two wires shows old fracture below its fracture end. The lay length of the strand was 180mm. The natures of fracture revealed out of 7 wires, 5 wires of corrosion fatigue failure and 2 wires of crystalline failure on full section wire (Figure 10C).

Figure 10C: Types of fracture of strand 3

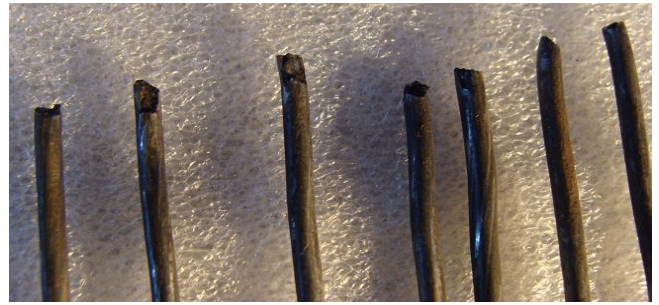
This strand shows 5 old fractures out of 7 wires below its fracture end. The lay length of the strand was 180mm. The natures of fractures are: 2 wire of conical tensile failure and 5 wire of corrosion fatigue failure (Figure 10d).

Figure 10d: Types of fracture of strand 4

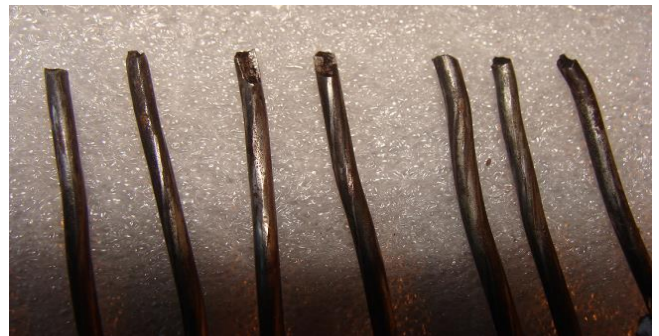
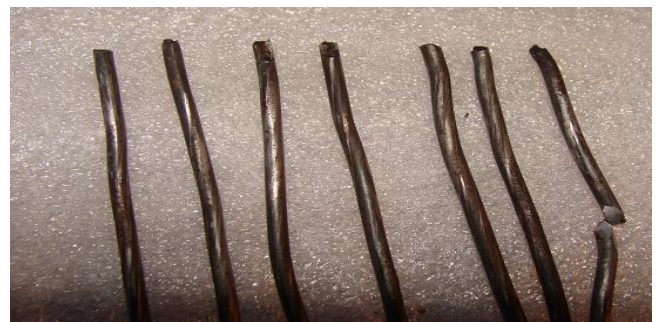
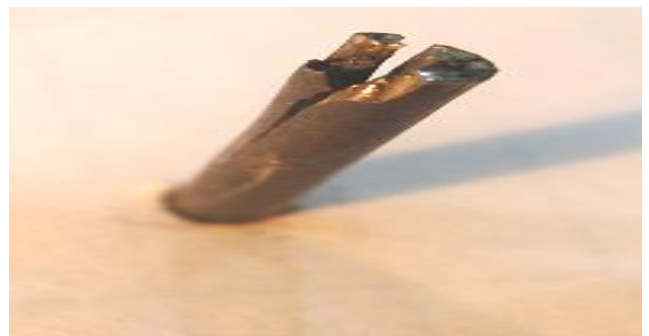
This strand revealed 1 wire has crack near the fracture end out of 7 wires. The lay length of the strand was 185mm. The Nature of fractures are, 2 wire of conical tensile failure, 2 wires of crystalline failure on full section of wire and 3 wire of corrosion fatigue failure Figure 10(e-I), Figure 10(e-II) & Figure 10(e-III).

Figure 10(e-I): Types of fracture of strand 5

Figure 10 (e-II): Types of fracture of Strand 5 with one wire broken from the middle

Figure 10(e-III): Types of fracture of Strand 5
Strand 6:

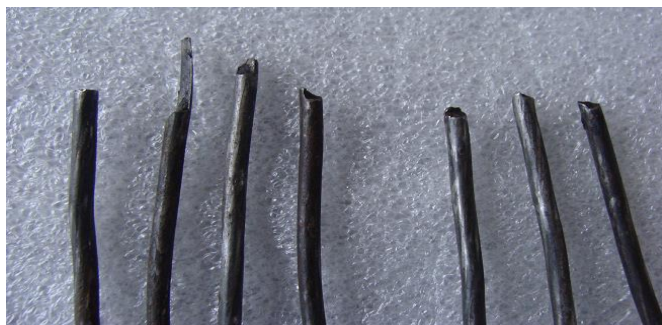
This strand shows tensile bending. The lay length of the strand was 173mm. The natures of fractures are: 1 wire of martensitic failure with fatigue crack developed and 6 wires of fatigue failure (Figure 11).

Figure 11: Types of fracture of strand 6

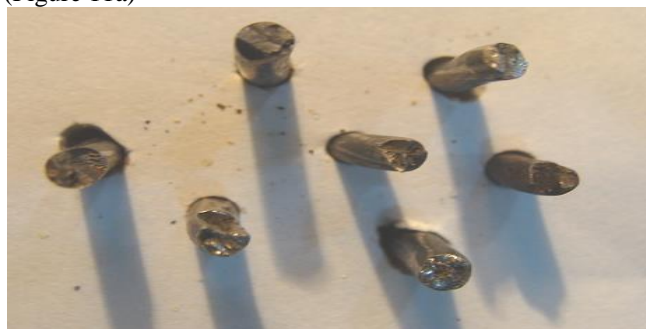
Nature of fracture of transverse section in broken ends: (Figure 11a)

Figure 11a: Types of fracture of strand 6

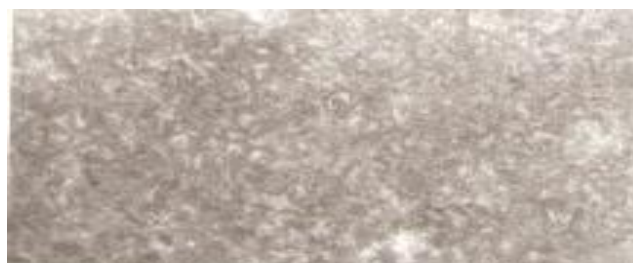
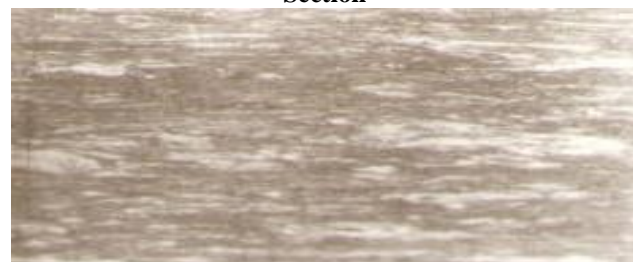
After etching in 1% nital solution the transverse section revealed uniform distribution of sorbitic pearlitic structure Figure 12a and the longitudinal section revealed good cold drawn structure Figure 12b of high carbon steel with peripheral damage of zinc coating & corrosion pittings Figure 12c and Microstructure also reveals structural displacement towards the tensile loading Figure 12d.

Figure 12a: Sorbitic - pearlitic structure in transverse Section

Figure 12b: Good cold drawn structure in longitudinal section
